## Lindquist Farm Project

In December, 2009 members of Bucks County Trout Unlimited planted the last of 1000 trees along Watson Creek on the Lindquist Farm in Buckingham Township. With these trees in the ground the chapter's largest stream restoration project in its history was completed. The project included removal of a dam, stabilization of 450 feet of eroding streambank, a riparian buffer planting of native trees on 1,500 feet of Watson Creek and stream temperature monitoring within the project area. This project was funded by the National Fish and Wildlife Foundation's Delaware Estuary Program ([www.nfwf.org](http://www.nfwf.org)).

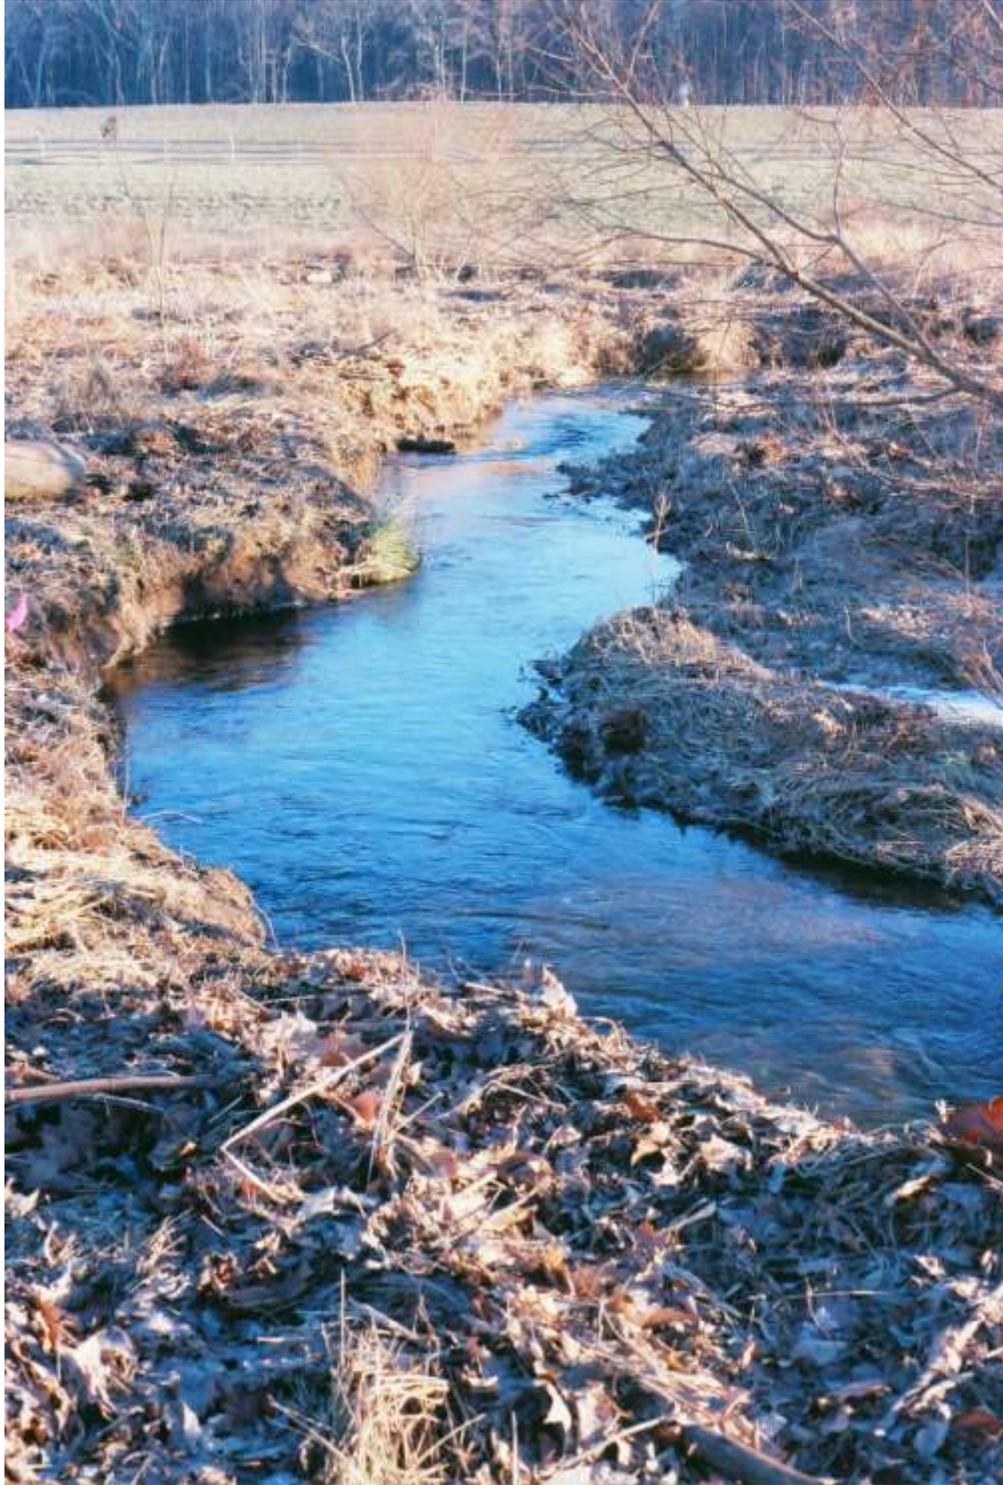
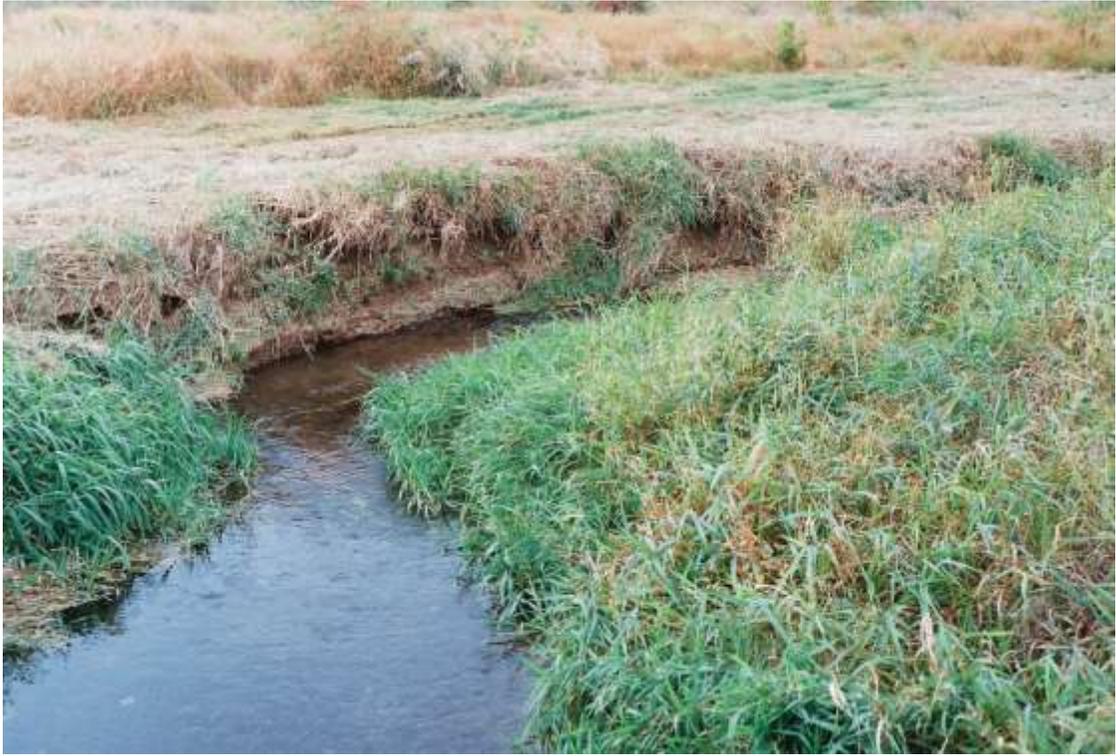
The project area is a reach of Watson Creek that flows through former pasture; it had little existing riparian buffer, mostly non-native herbaceous vegetation (see photos 1&2). Stream banks were severely eroding throughout much of the reach (see photos 3 & 4) and a dam impeded fish passage (see photo 5). The reach lacked many of the factors that are known to be important for a healthy stream ecosystem: forested riparian buffer, stable vegetated stream banks, lack of large woody debris in the stream and a dam that contributed to isolation of fish populations in the watershed.

The riparian buffer restoration involved planting over 1000 native trees, 400 native shrubs and 200 native wildflowers. All the plants used in the buffer restoration are native to the Piedmont physiographic province. To aid in survival of the trees, each was protected with a tree shelter to protect them from damage by deer (both browsing and antler rubbing by bucks) and a rodent guard was installed at the base of each to protect from voles gnawing on the bark (see photos 6, 7 & 8). Restoration of a forested riparian buffer will contribute to a healthier stream in a number of ways. The buffer will filter pollutants from runoff before it reaches the stream. It will shade the stream and help reduce water temperature. Colder water carries more dissolved oxygen than warmer water and so can support a more diverse fish and aquatic macroinvertebrate community. The trees will be an immediate source of leaf matter in the stream which is an important energy source for the food web. After leaves fall or are blown into the stream chemicals within them begin to leach out and contribute to Dissolved Organic Matter (DOM) in the stream ecosystem. DOM is an important energy (food) source for microbes that form the base of the food web. Once in the stream and now characterized as Coarse Particulate Organic Matter (CPOM), leaves are invaded by bacteria and fungi; this is important for the aquatic macroinvertebrates that feed by shredding leaf matter as the bacteria and fungi increase the nutritional value of the leaves. Many species of mayflies, stoneflies and caddisflies are “shredders”. Having been shredded and subject to physical abrasion in the stream, the CPOM becomes Fine Particulate Organic Matter (FPOM) and is now an energy source for a different set of aquatic organisms.

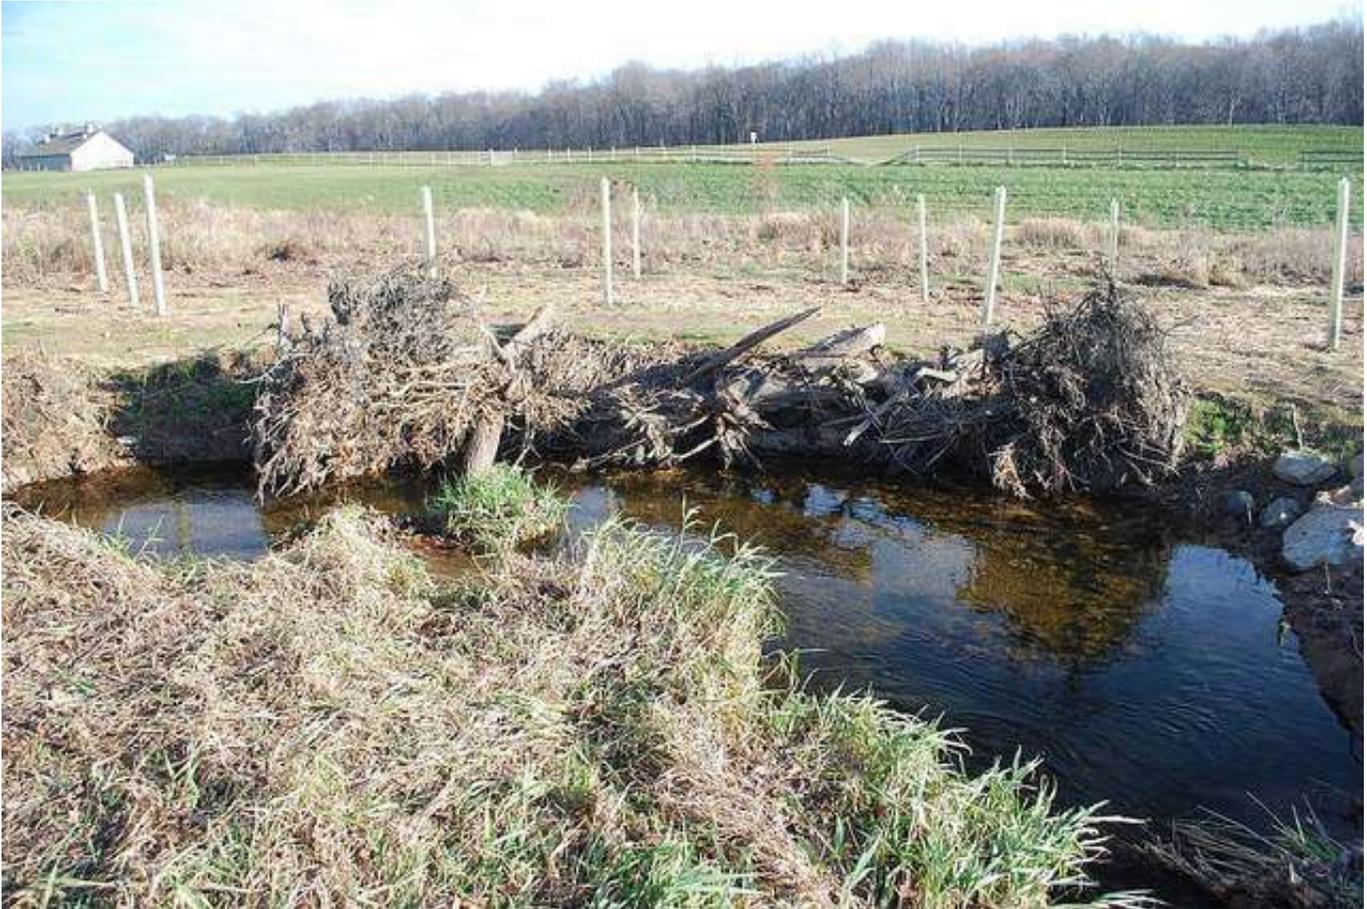
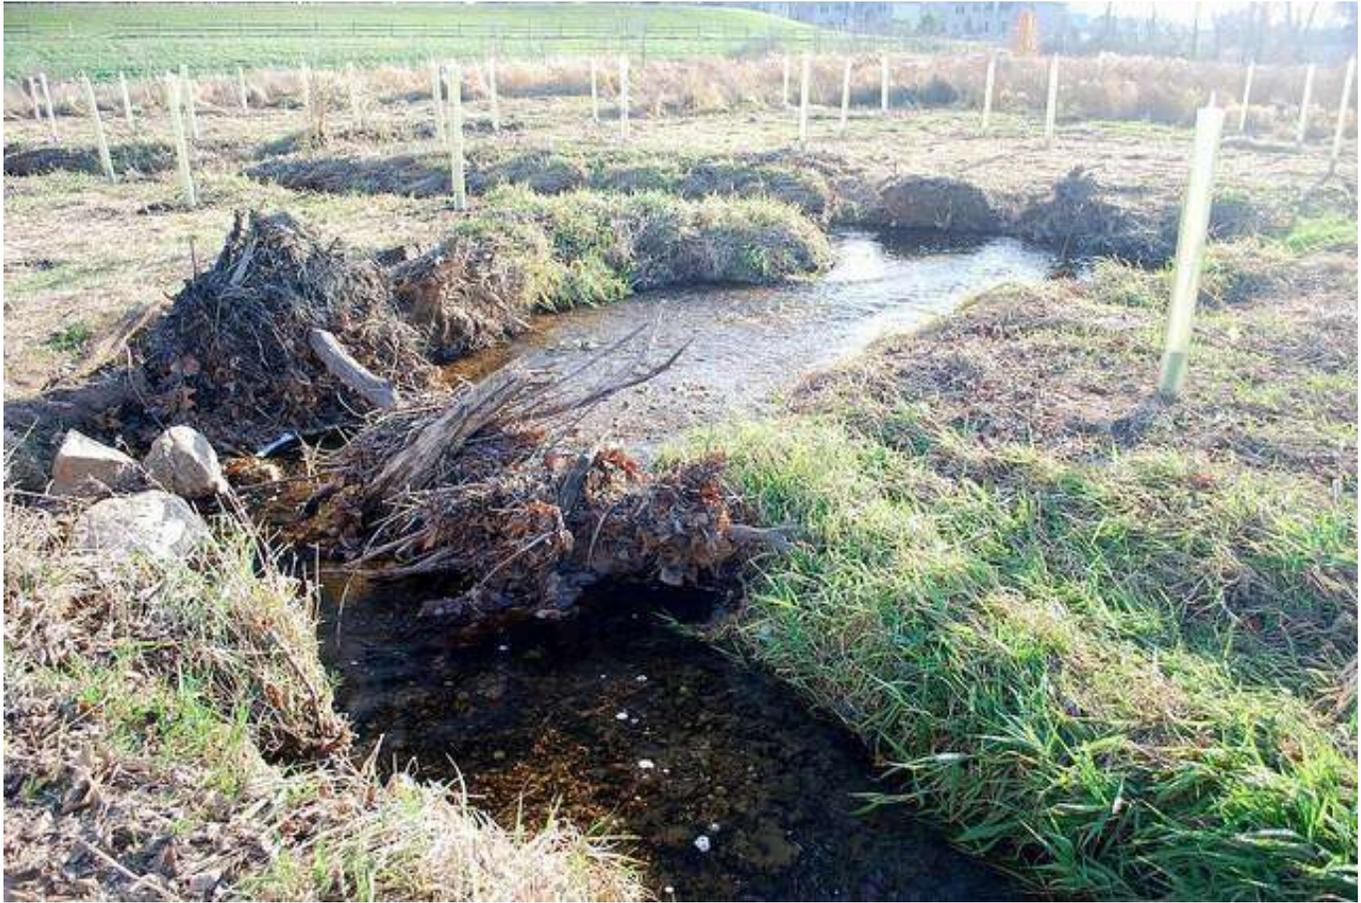
a large tree falls into the stream it will often result in a scour pool forming downstream of it and so creates habitat for trout and other fish. As the project area lacked existing woody debris and the trees that were planted will not be a source of large woody debris for many decades, some woody debris in the form of “root wads” was incorporated into the restoration plans. A root wad is a 10 to 12 foot section of tree trunk with the roots still attached. The root wads used had trunks from 12 to 24 inches in diameter and were salvaged from building construction sites. The root wads that were installed will perform many functions that contribute to the health of Watson Creek. They will trap CPOM, create overhead cover and scour pools for trout and were installed to help stabilize some of the eroding banks in the project area (see photos 9 & 10).

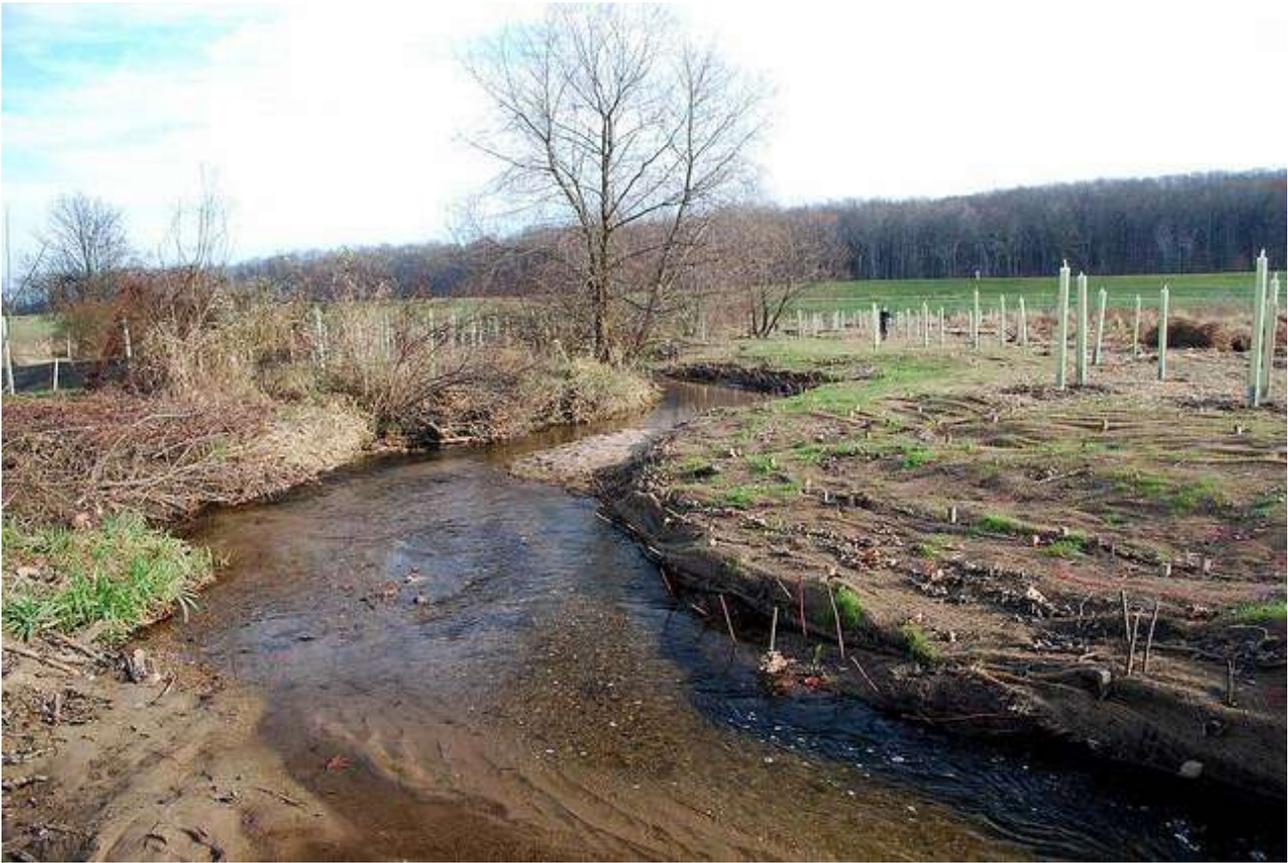
PHOTO 11

The stabilization of 450 feet of eroding streambank in the project area will greatly reduce the amount of sediment entering Watson Creek. Sediment is the number one pollutant in rivers and streams in the United States. Too much sediment affects the stream in a variety of ways. Many of the stream macroinvertebrates live in the interstitial spaces of pebbles and cobbles on the stream bottom. Too much sediment can fill these spaces (substrate embeddedness) and so reduce the diversity of the stream macroinvertebrate community. Trout require areas of clean gravel free of sediment in which to spawn. Trout eggs are deposited and develop in the interstitial spaces of the substrate; these spaces provide protection from predators and water flowing through the spaces provides oxygen to the eggs. Pollutants, especially phosphorous, can also bond to sediment particles and so remain in the stream for longer periods. Two different methods were used to stabilize banks. The use of root wads as described above was used on about 100 feet of streambank. Approximately 350 feet of bank was graded from vertical to a less severe slope, a native seed mix of wildflowers and grasses was put down and then covered with erosion fabric (see photos 11 & 12). It was then planted with various native shrubs and herbaceous plants including, willow, red-twig dogwood, ninebark, alder, joe-pye weed and cardinal flower. As these plants grow their roots will stabilize the bank and they will remove pollutants, especially nitrogen and phosphorous, before they reach the stream. Of course, these plants will also provide habitat for birds and terrestrial insects.

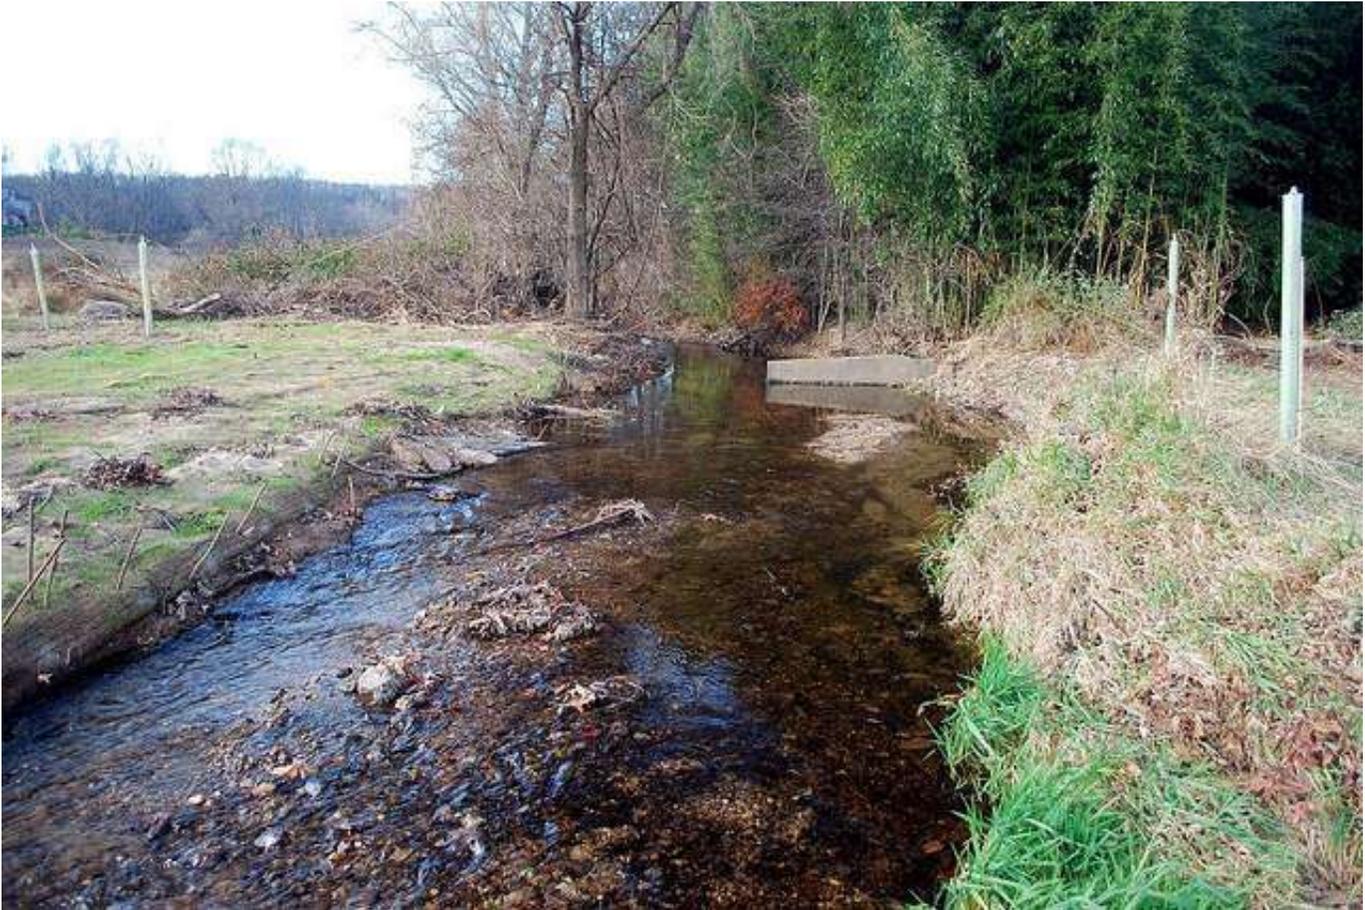
PHOTO 13

The dam that was removed will allow fish passage upstream and downstream and will restore the natural process of sediment transport downstream. It will especially allow trout to gain access to higher quality spawning habitat, colder water and a gravel/cobble substrate, in upstream reaches of the watershed (see photo 13).
